TC10 Single Lever Tap

CDA

TC10 Single Lever Tap – Technical Bulletin

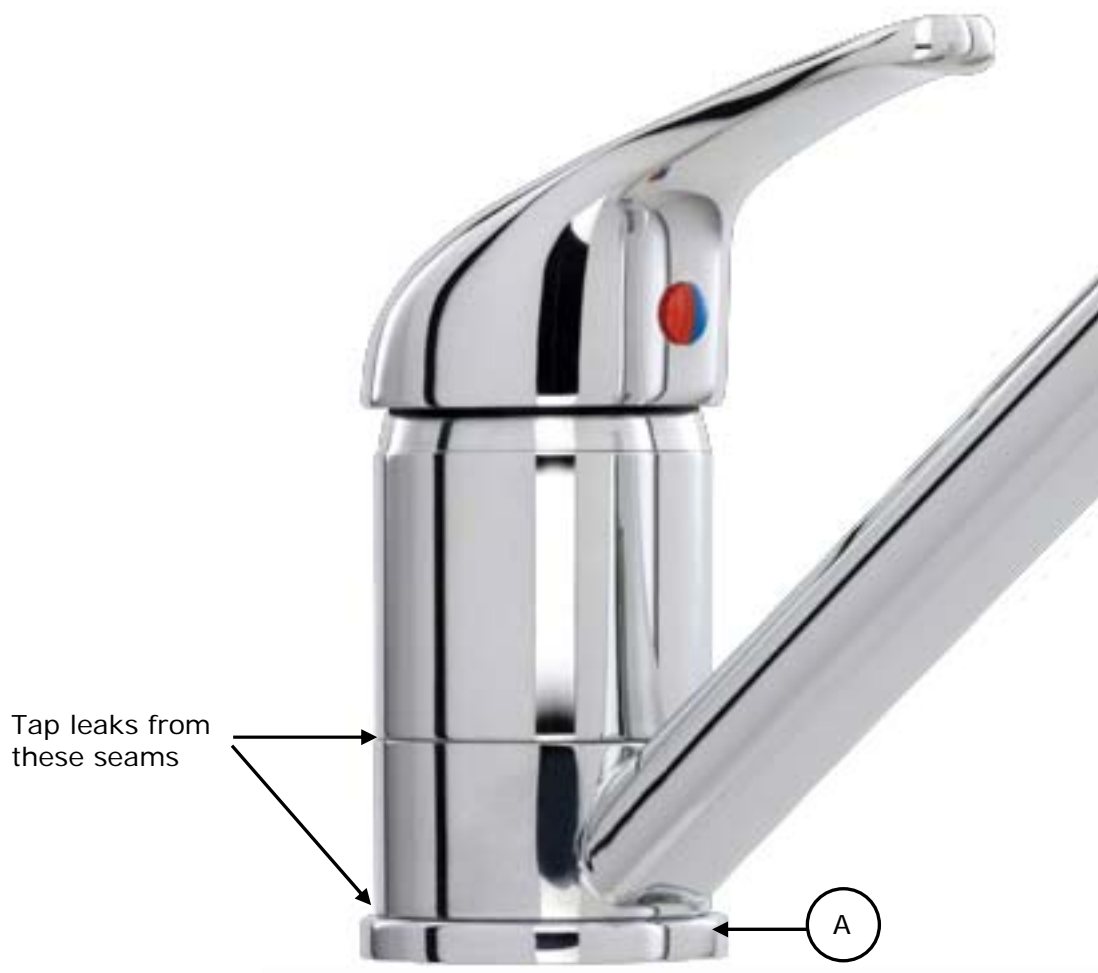
Customers report that the tap is leaking from the spout, as shown on the photograph below. This is caused when the collar, shown as A on the photograph, is not tight enough.

Loosen the securing nut, clamping the tap to the sink (underneath the sink) and turn the collar clockwise until hand tight. Re-tighten the fixing nut and the issue should be resolved
